**Docket No. 217 – Development and Management Plan Inspection**

**Date:** January 4, 2006

**Location:** 345kV Underground Route

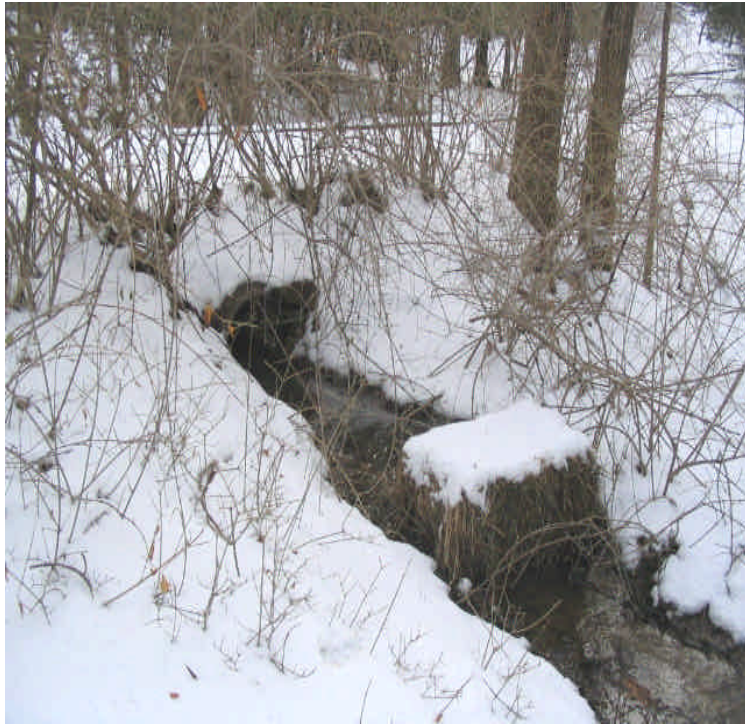
**345kV (Umpawaug Rd Daywork):** No active trenching was occurring. Both photos are near #79. Photo on the left shows haybales remaining in the swale. Photo on the right shows the spot where water runs down to the stream which is currently blocked by snow. 1/4/06

| Areas of Inspection | Observation | Recommended Action |
|---|---|---|
| Umpawaug Rd. | <p>-Active trenching is not occurring at this time. Controls at Wayside Lane had some gaps and holes adjacent to the wetland. Silt fence was down near a wetland at Mallory Lane. 12/30-1/4/05</p> <p>- Haybales were still needed across the street from #79 at the top of the gully but the area was currently covered with snow. 1/4/06</p> | <p>-None at this time but the controls should be repaired <b>IF</b> active work returns here. 1/4/06</p> <p>-Reduce run-off here when feasible. 1/4/06</p> |

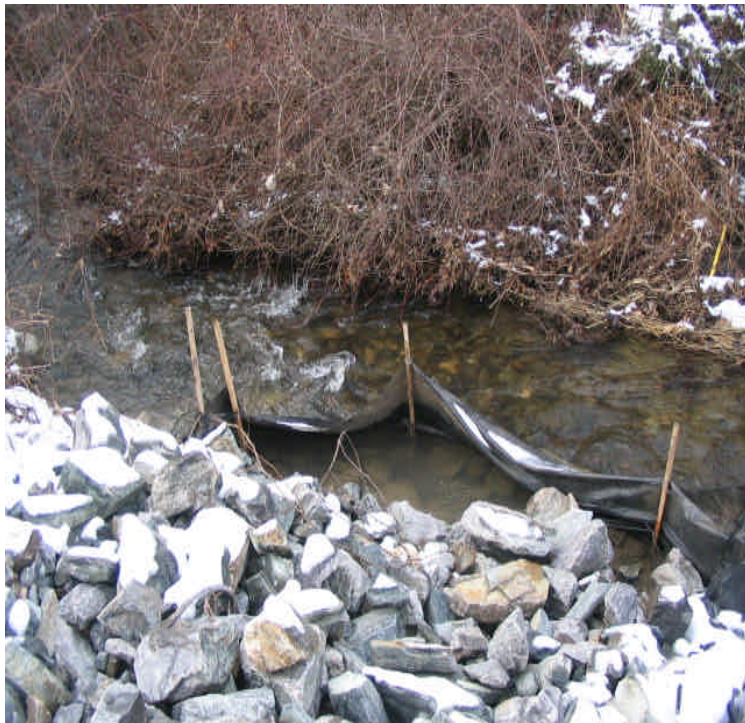
**345kV (Georgetown Deli Jack and Bore):** Photo on the left shows the stream with some minor turbidity retained in the silt fence. Photo on the right shows the overall site with frac tanks remaining in place. 1/4/06

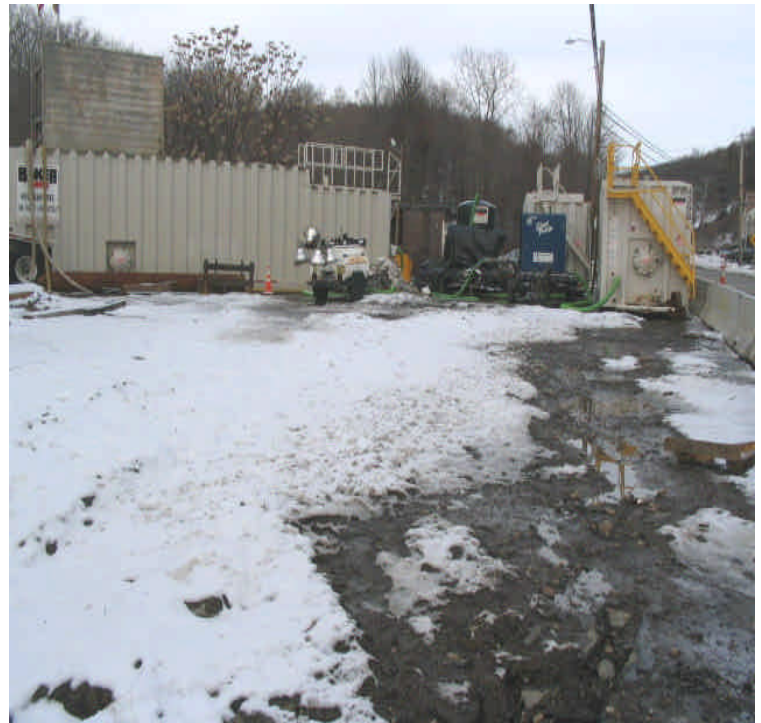
| Areas of Inspection | Observation | Recommended Action |
|--|---|---|
| Dewatering | - Several frac tanks are still in place at the Georgetown Deli parking lot in order to hold the water from the jack and bore pits here. They have cycled | <p>- Continue to monitor for effectiveness. The water in the stream was running clear. 1/4/06</p> <p>- Slight turbidity is noted with</p> |

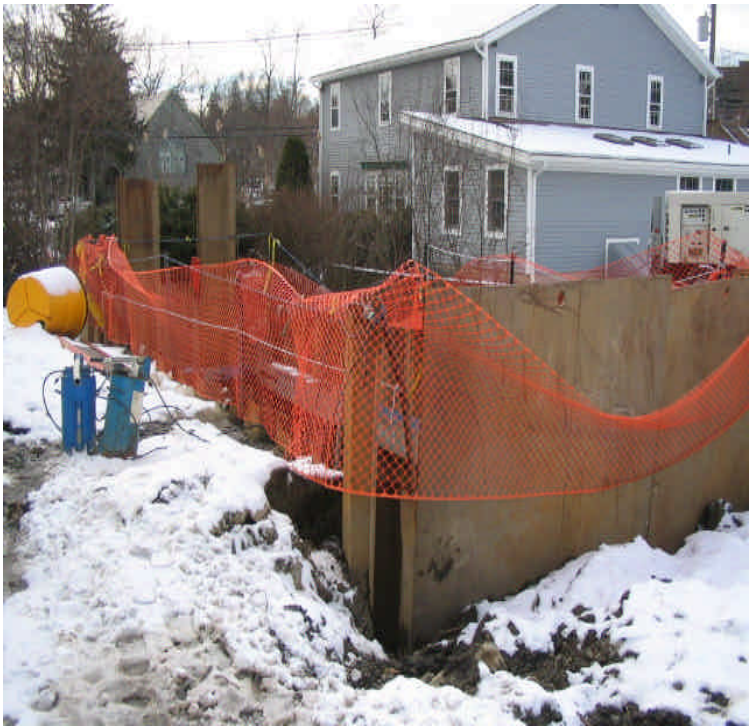
Photo on the left shows the bore pit side of the work. Some backfilling has already occurred here. The photo on the right shows the sandbag and silt fence controls adjacent to the stream on the receiving pit side. 1/4/06

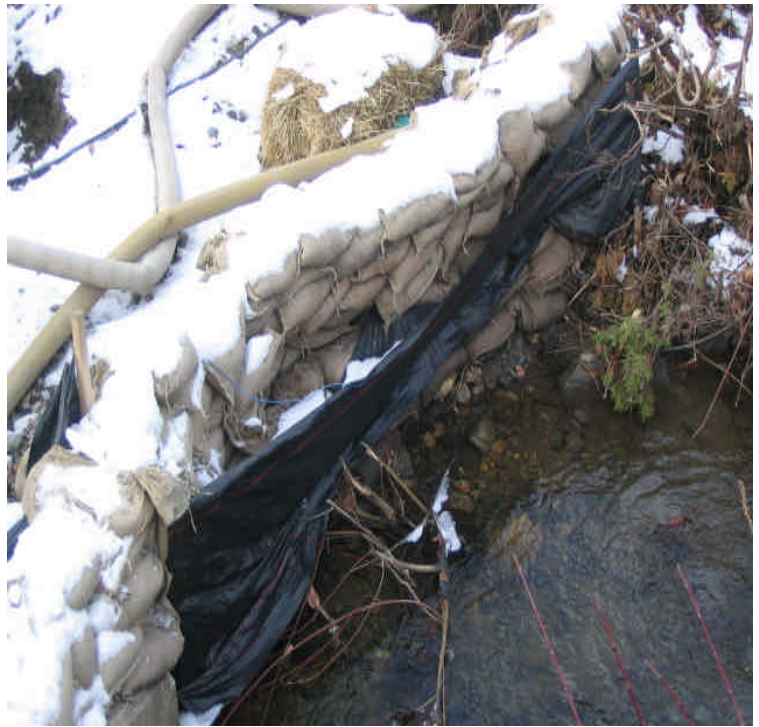
| Areas of Inspection | Observation | Recommended Action |
|---|--|--|
| <b>Rt. 107 Daywork</b> | <p>- The J&amp;B operation at the Georgetown Deli appears mostly contained and some backfilling had occurred. More sandbags/silt fence were installed along the stream bank. 1/4/06</p> <p>-The silt fence at the base of the dewatering outlet was back in place and contained some turbid water. 1/4/06</p> <p>- Active trench work/pipe installation continued on a slope above the Norwalk River. Silt fence was in place. 12/22-1/4/06<br/>Controls were also in place along the parking lot edge where soil was stockpiled. 1/4/06</p> | <p>- Continue to monitor and maintain controls adjacent to the stream . 1/4/06</p> <p>- Dewatering and regular filter changes are still occurring as evident by a large number of used filters. 1/4/06</p> <p>-This was fairly well contained and the stream was running clear. 1/4/06</p> <p>- None at this time but monitor the status of fence and controls here carefully due to the steep grade and river below. 12/22-1/4/06</p> |

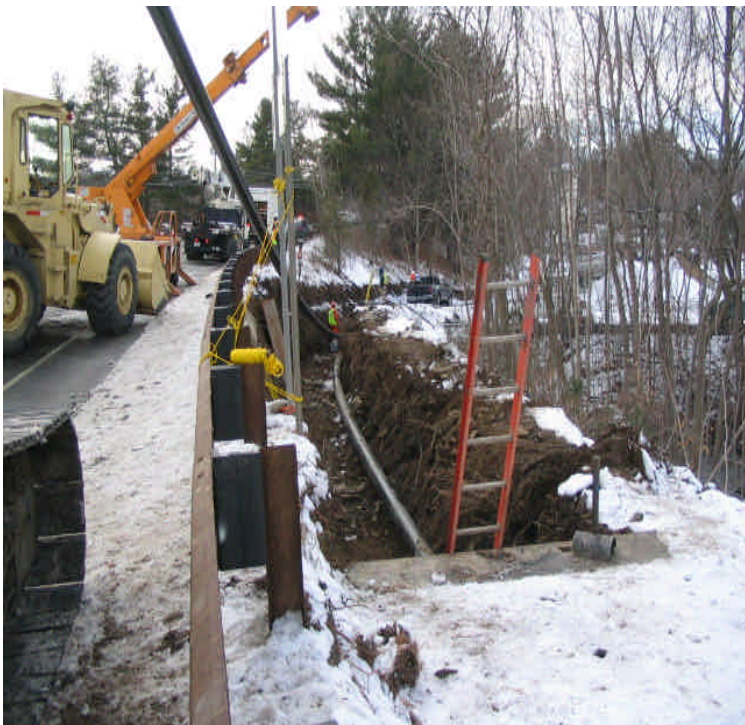
345kV (Rt. 107 Norwalk River work) Photo on the left shows an overview of the trenchwork with the pipes being installed. Photo on the right shows a view down towards the river with erosion controls well installed. Controls are also in place along the parking lot where soil is stockpiled.

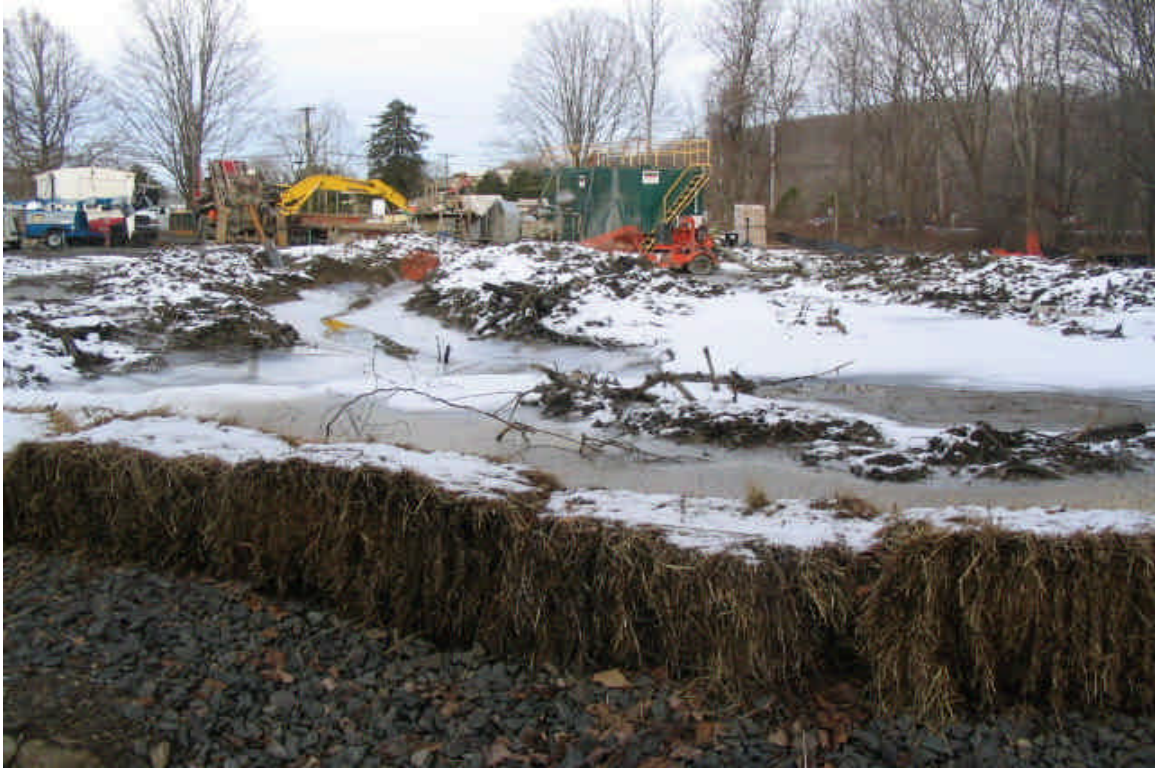
| Areas of Inspection | Observation | Recommended Action |
|--|--|--|
| | - The Horizontal Direction Drill at School Rd. issues with turbid water and the containment are still present. 12/8-1/4/06 Some water removal and excavation had occurred in some spots 1/4/06 | -Turbid water as a result of drilling needs more attention here. There is a large amount of exposed surfaces as well. See additional sections for more details.12/8-1/4/06 |

345kV (HDD): Overall view of the site. It appears that some excavation may have occurred in the detention basin area. Ice/mud levels still remain high towards the back berm. 1/4/06

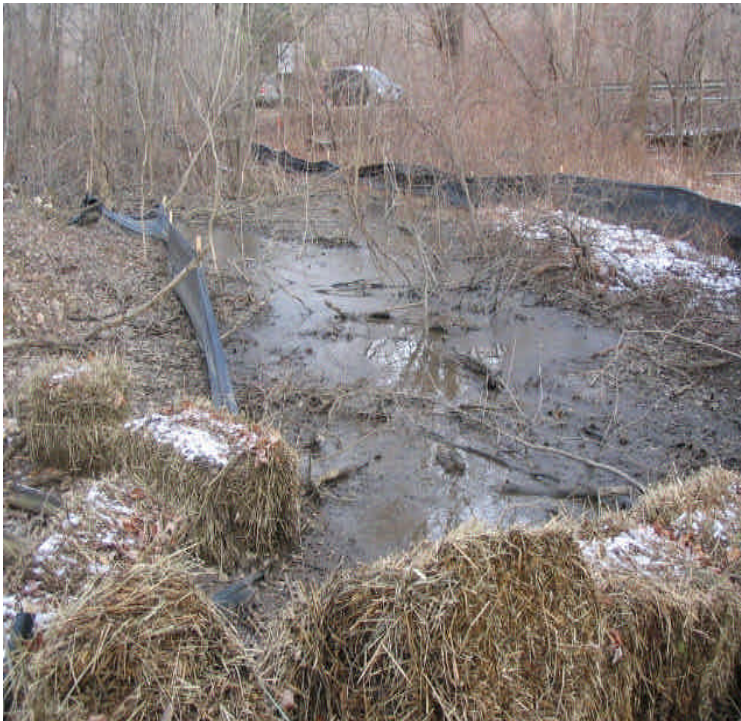
Photo on the left shows the ponded area to the east of the basin where turbid water has pooled. Photo on the right shows where some of the water and mud may have been removed. 1/4/06

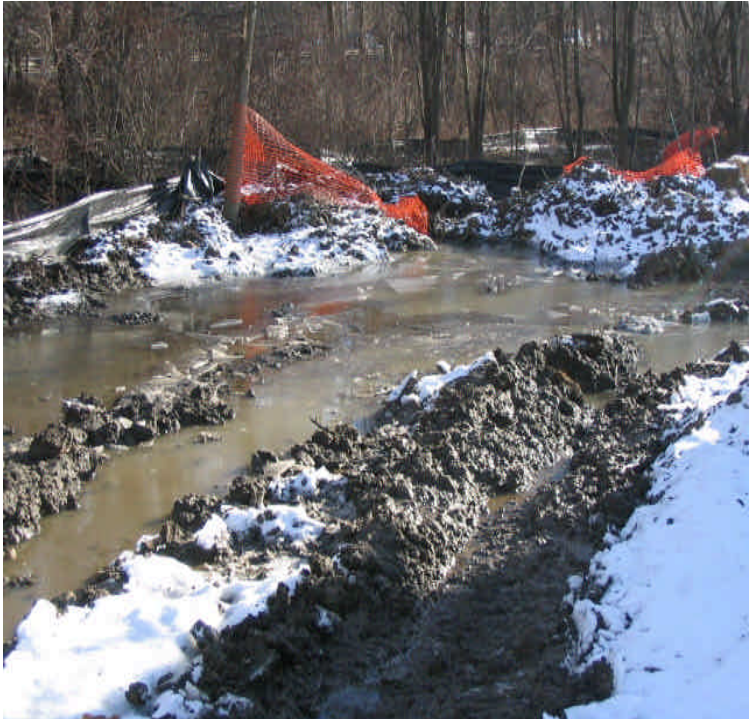
| Areas of Inspection | Observation | Recommended Action |
|--|---|---|
| | <p>School Rd. HDD area includes a lot of bare, exposed soil and turbid washwater. Stabilization is needed here for equipment movement as well. 12/14-1/4/06</p> <p>- The racquet club storage yard has been very active with a lot of materials. Make sure inlets here are protected. 10/27-1/4/06</p> <p>- A new storage area was noted across from Old Highway Rd. An unidentified open container/pail was noted here. 1/4/06</p> | <p>and stabilize the area better. 12/14-1/4/06</p> <p>- Keep within the limits of the yard and don't encroach into the brush. 10/27-1/4/06</p> <p>- Be sure to pick up and contain all potentially spillable materials by the end of a work day. 1/4/06</p> |

Photo on the left shows turbid water still pooling in other areas adjacent to the basin. The area is highly disturbed and needs some additional support for equipment access. The photo on the right shows turbid water from the drill cuttings outside the tank. The silt fence here needs repair and this area should be contained better. 1/4/06

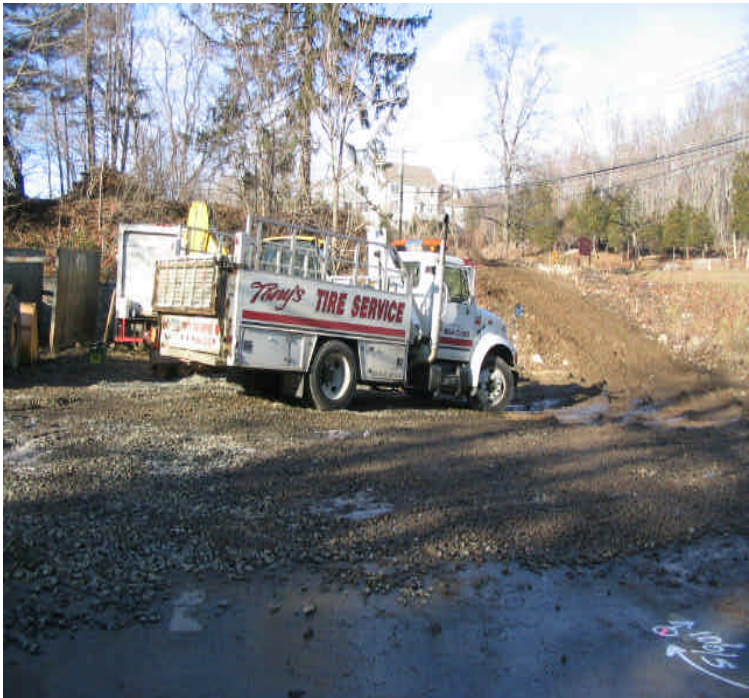
345kV (Rt. 7 and Norwalk Junction): The photo on the left is a view of another work/storage area noted across from Old Highway Rd. Photo on the right shows a view of a recently installed vault at Norwalk Junction. Work on the vault is mostly complete, including active dewatering. 1/4/06

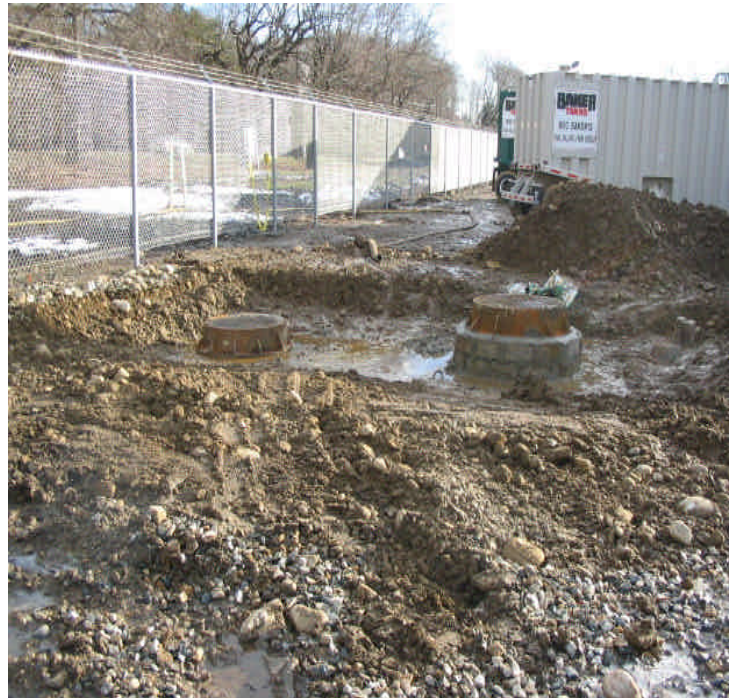
| Areas of Inspection | Observation | Recommended Action |
|--|--|--|
| | - The vaults at the Norwalk Junction site were mostly completed the day of inspection. 1/4/06 | -Some issues needs attention. See other sections for details. 1/4/06 |

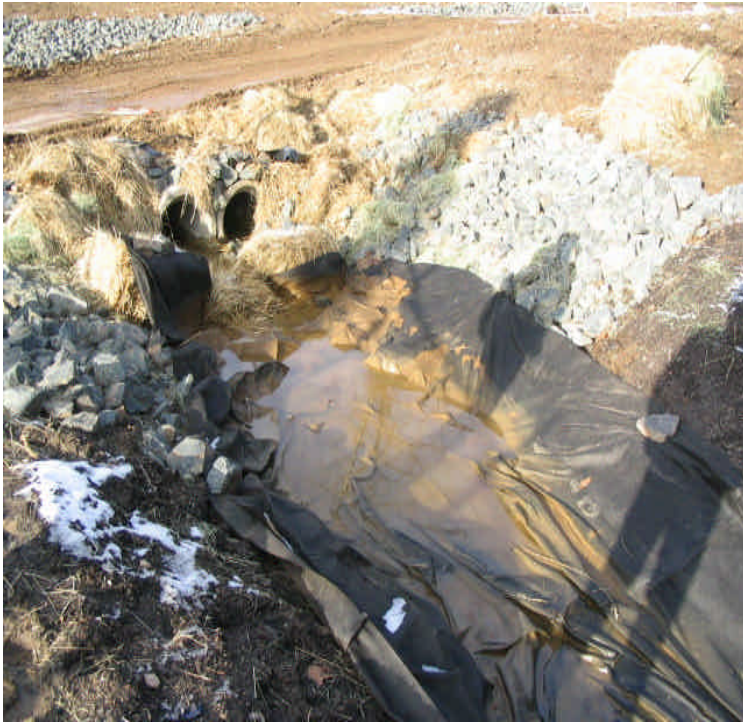
| Areas of Inspection | Observation | Recommended Action |
|---|---|---|
| | <p>millions of gallons of water since the start of the project. 12/1-1/4/06</p> <p>- Significant dewatering had been required at the vault installation at Norwalk Junction but it was recently completed. The filter bag was still draining. Noticeable sediment was well contained but water entering the culvert was still somewhat turbid. 1/4/06</p> | <p>in the silt fence. 1/4/06</p> <p>- Frac tanks were still in place but had filled up too quickly. Groundwater is extremely high. See erosion control section for more details. 1/4/06</p> |

Photo on the left shows the swale where the filter bag continues to discharge from the recently completed dewatering. A large amount of silt has been removed and collected by the controls here but the water entering the culverts is still somewhat turbid. The photo on the right is a close-up view of the culvert. 1/4/06

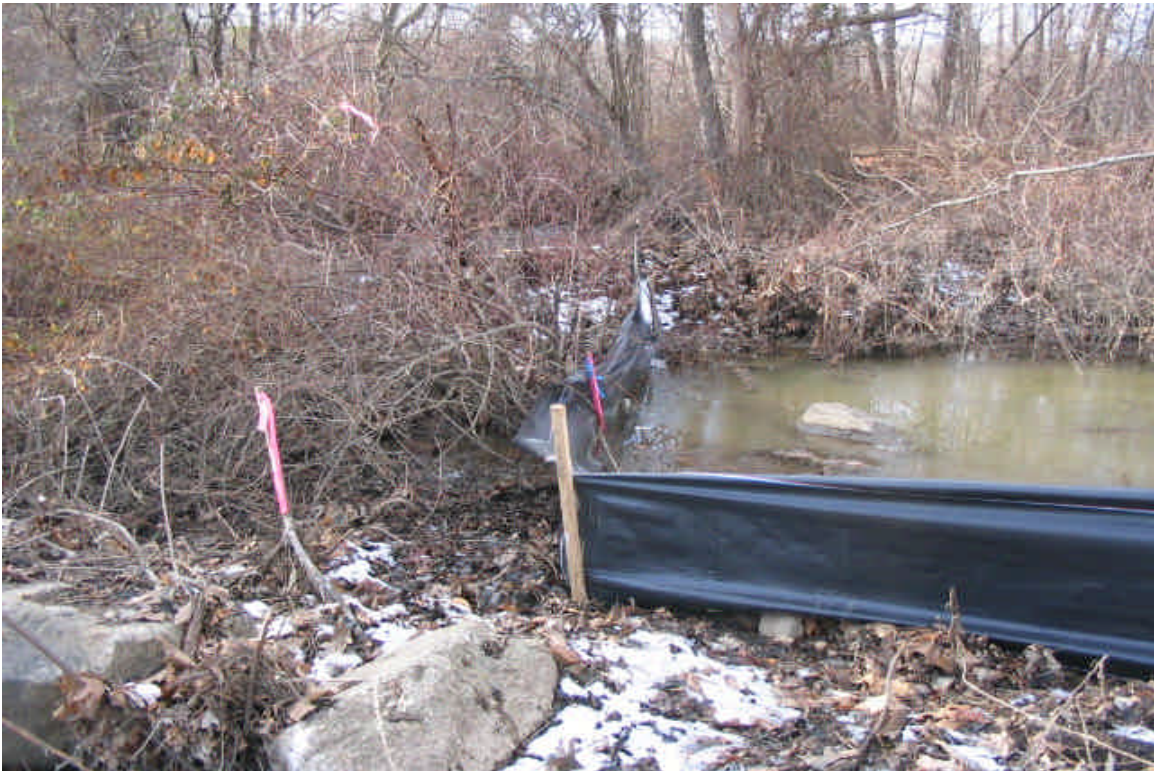
The photo shows a view of the turbidity in the wetland adjacent to the Norwalk River. Additional silt fence was installed as requested which prevents most of the turbidity from getting to the river. 1/4/06
